## GENERAL GUIDELINES ON TIPPER TRUCK COVERS

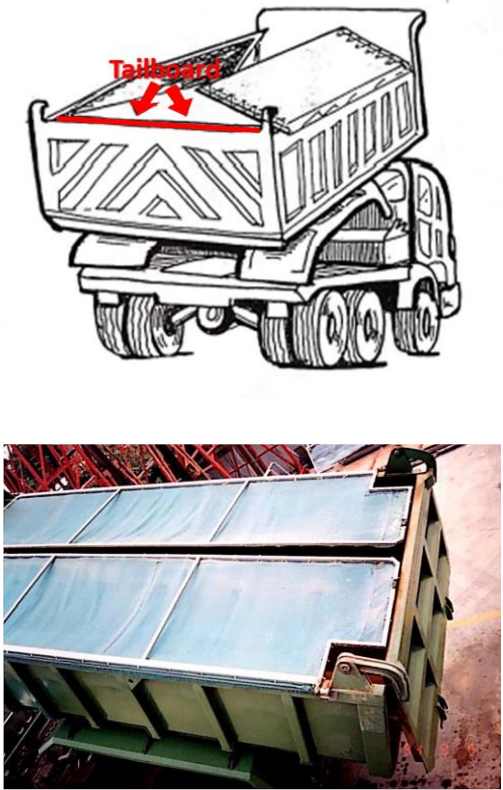
S/N	Recommended practice	Sample Images
1	Cover is horizontal when truck is plying public roads and load transported is below the height of the tailboard.

<p>The 'Sample Images' column contains two visual references. The top image is a line drawing of a tipper truck from a rear-quarter perspective. A red horizontal line is drawn across the top of the truck's bed, labeled 'Tailboard' in red text with two red arrows pointing to the line. The bottom image is a photograph of a green tipper truck with a blue tarp cover over its bed. The cover is held flat and horizontal, matching the recommended practice.</p>

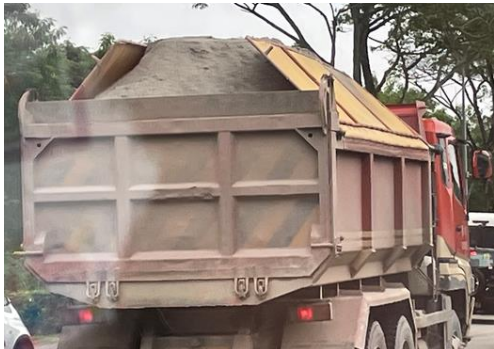
S/N	Scenarios where enforcement action would be taken	Sample Images
1	Truck loads exceed the height of tailboard and are not completely covered

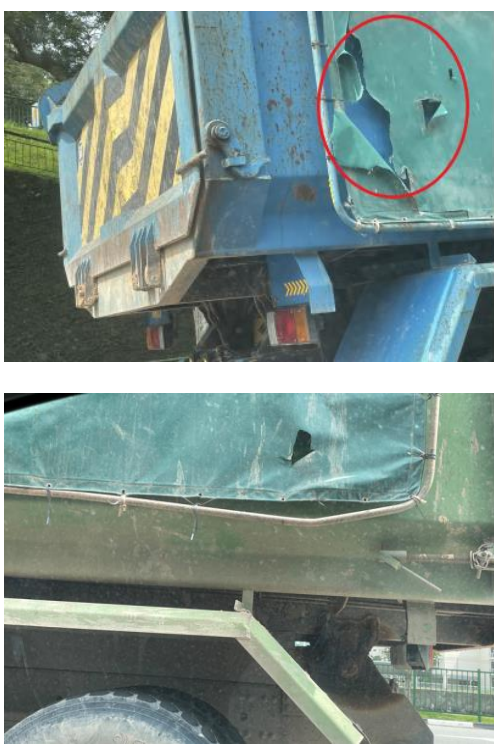
2	Trucks with torn/defective covers
